## Outline Case Study

**Site :** Surrey

**A significant manor house dating from 1620-1710 sitting on approximately 20 acres.**

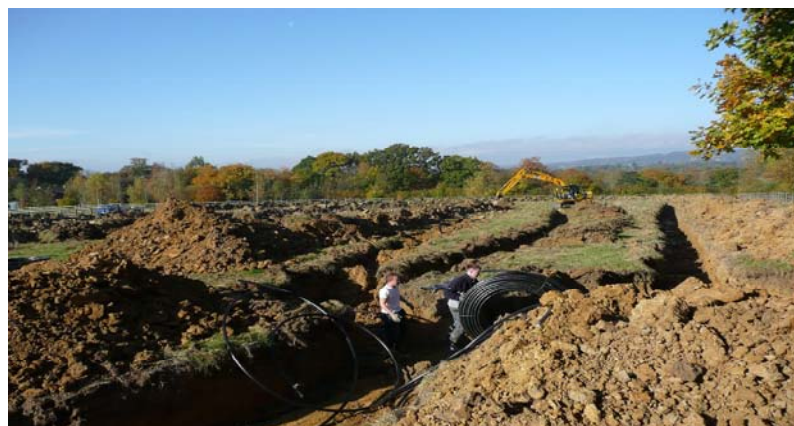
**Spatial heating and hot water for the main house via 2 x 40kW Ground Source Heat Pumps.**

**Source taken from a 4200m surface soil horizontal collector field located in an adjacent paddock.**

**Outdoor pool heating and spatial heating and hot water for ancillary buildings via 1 x 14kW Air Source Heat pump.**

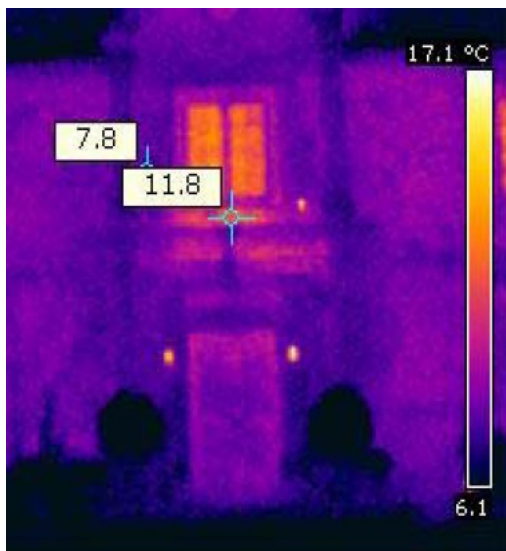
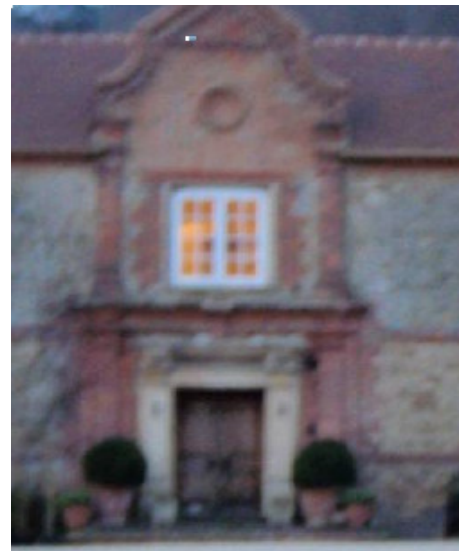
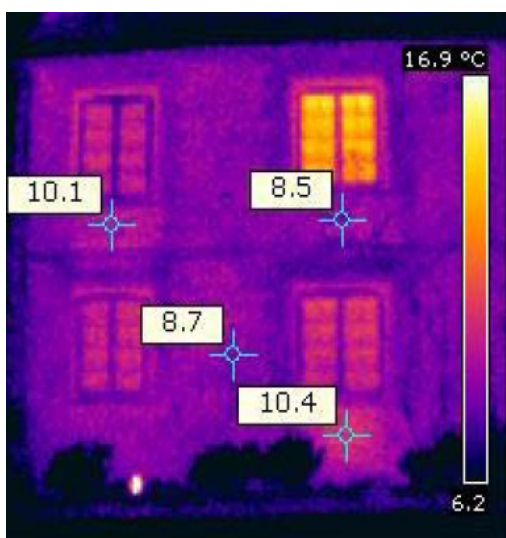
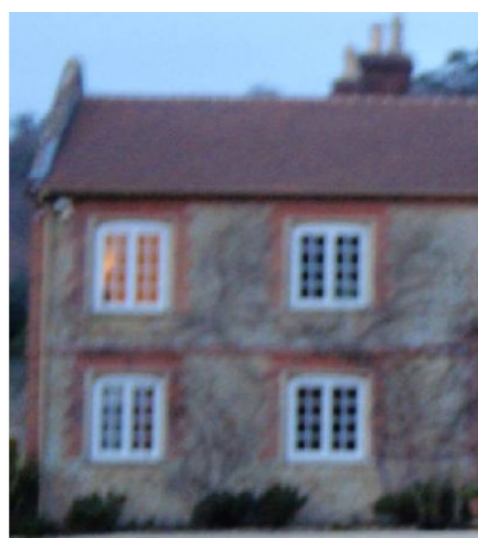
A subsequent thermal imaging survey on this significant manor house from 1620 showed significant heat loss from windows but no loss from the roof.
